Corrosivity study in Usiminas continuous casting machines segments

Abstract

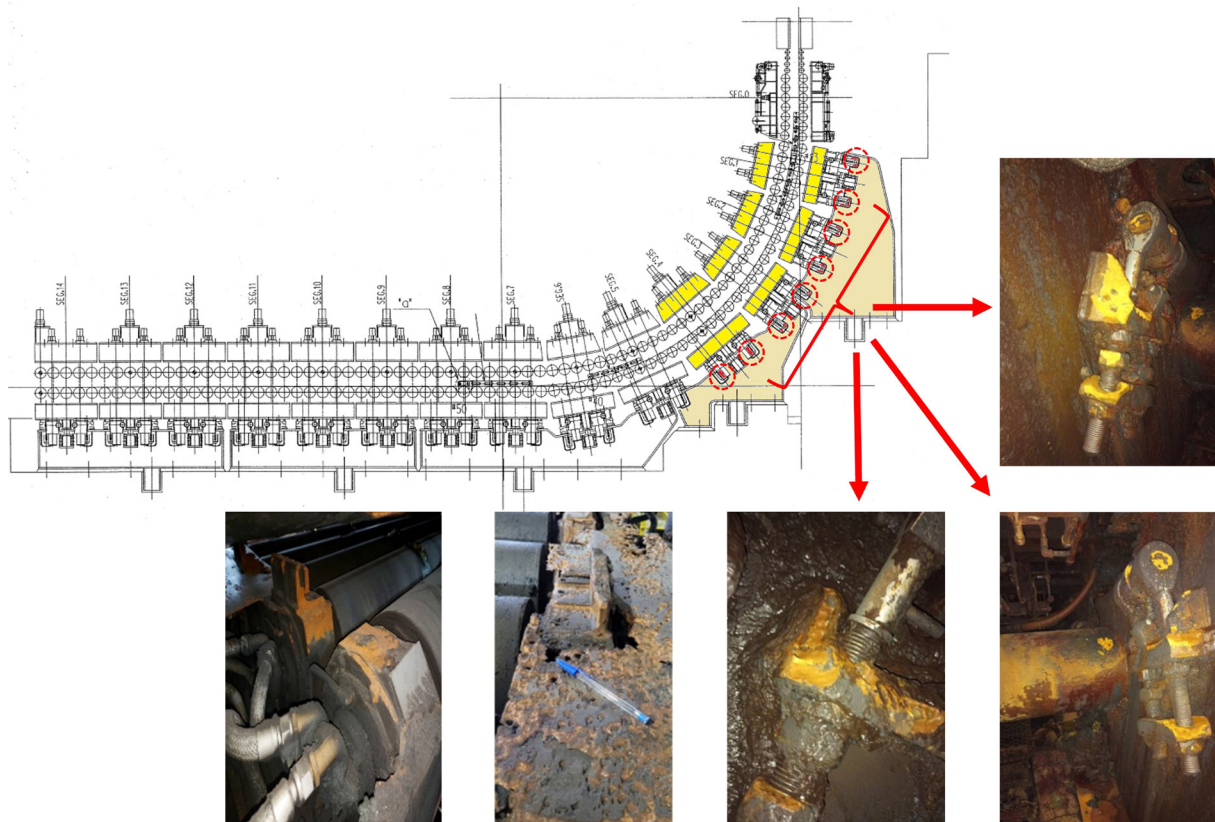
At the beginning of 2022, during visual inspection, considerable corrosion was observed in the segments of the CCMs of Usiminas, mainly in places close to the curvature region, the corrosion was evidenced by the attack on the protection plates and tie rods that fasten the segments, as shown in Figure 2. This event boosted the monitoring of the parameters of the water used in the process and the development of the present work. In this context, the objective of this work is to support actions to neutralize the deleterious effect of fluoride ions and, thus, preserve the structures of the machines.

Figure 2. CCM structures with intense corrosive attack.

- Machine washing after interruptions in the process for removing any remaining acid residue;

- Increase the frequency of visual inspections on the CCM structures, with the taking of photographic records for comparison at each inspection;
- Replacement of NaOH by Na₂CO₃ in the water treatment in CRALIN, in order to increase the alkalinity of the water to a range of 50 to 90 mg/l and thus neutralize the acid.

To increase the pH in the region of segments 1, 2 and 3 and neutralize the HF formed, an additional NaOH dosage system was designed during the process in these segments. The implementation of this system began at CCM#4 in February 2023 and it will be implemented at CCM#1 and CCM#2 after they have been overhauled. The NaOH is transferred from a storage tank directly to the water intake pipes of the most affected segments. In one second step, the dosage will be carried out only in situations of low pH during the process.

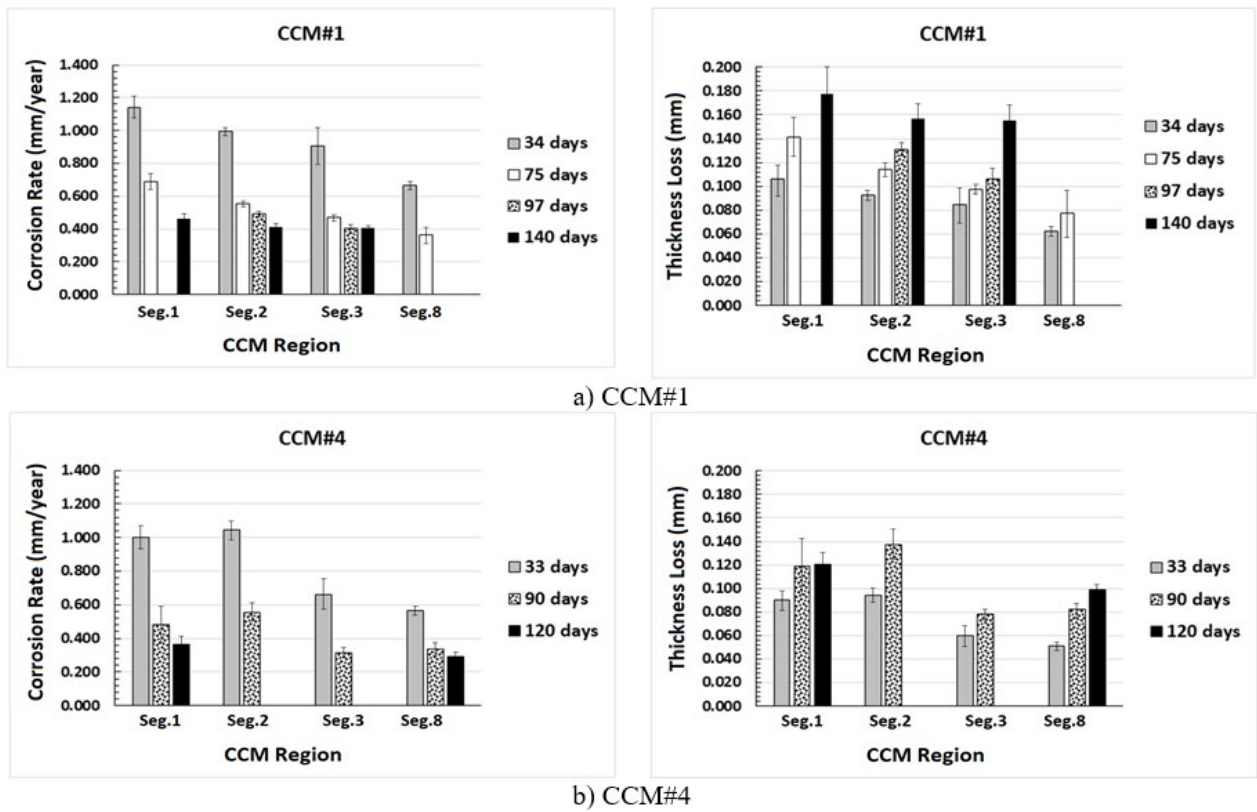
in Figure 5. The missing data in this figure correspond to coupons lost during the test, for example, coupons of 97 days of exposure in segment 1 of CCM#1. It is important to note that the corrosion rate can decrease over time due to the accumulation of corrosion products on the metallic surface, which slows down the corrosive process. If these corrosion products are not adherent, corrosion will continue and thus the thickness loss tends to increase over time, as shown in Figure 5.

From this figure, it can be observed that segments 1, 2 and 3 of both machines are characterized by the most aggressive environment. For the period of about 30 days of exposure, compared to the reference values in Table 1, segment 1 of CCM#1 presented the worst situation, with a corrosion rate near to 1.27 mm/year, a value considered critical. Segments 2 and 3 of this machine, as well as segments 1 and 2 of CCM#4, showed relatively high corrosion rates, around 0.8 to 1.10 mm/year. Low to acceptable levels (0.254 to 0.762 mm/year), were only obtained for segment 8 of CCM#1 and for segments 3 and 8 of CCM#4. It is desirable that the most critical segments, that is, 1, 2 and 3, present these levels for corrosion rate to avoid problems associated with structural corrosion of the CCM.

Figure 5. Corrosion rate and thickness loss of coupons exposed in CCM#1 and #4. a) Corrosion rate and thickness loss of CCM#1; b) Corrosion rate and thickness loss of CCM#4.

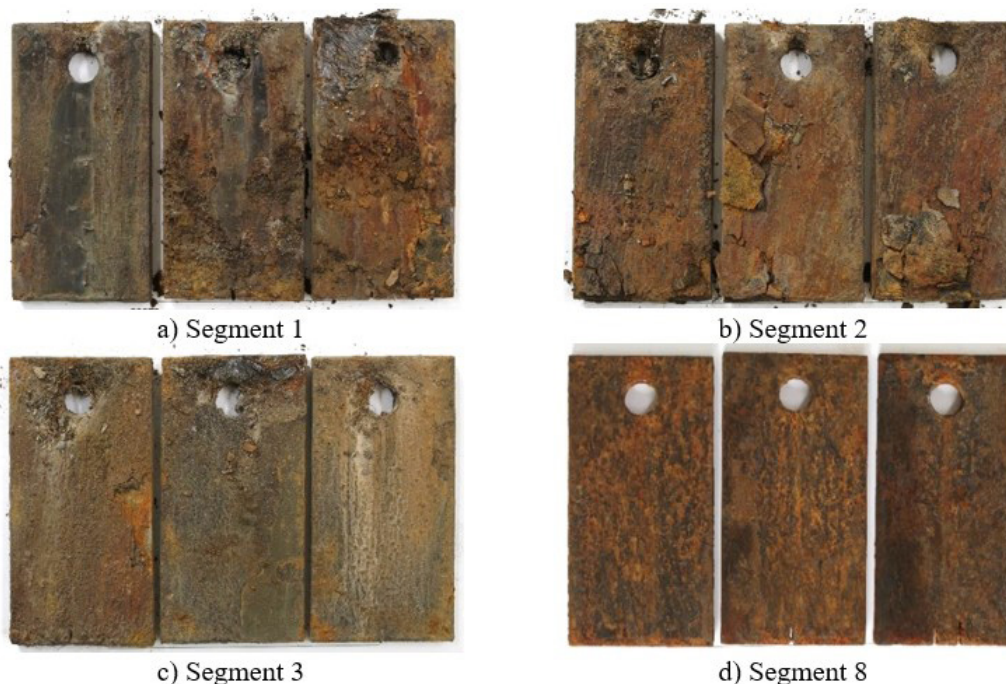
The visual aspect of corrosion coupons exposed for about 30 days in the different segments of the CCM is shown in Figure 6. Regardless of exposure time, a greater accumulation of corrosion products and residues was observed in the coupons exposed in the first three segments of both

CCM. The XRD analysis carried out on the surfaces of the coupons indicated the presence of magnetite, goethite, hematite and wustite iron oxides. The first three ones are

Figure 6. Typical appearance of coupons after corrosion test inside CCM.

normally observed in steel corrosion and the last one, wustite, usually forms at high temperatures [11]. Calcium fluoride (CaF_2) was also detected by DRX analysis, associated with these iron oxides. CaF_2 is a compound originating from mold flux and whose reaction with water, at high temperatures, forms hydrofluoric acid [12].

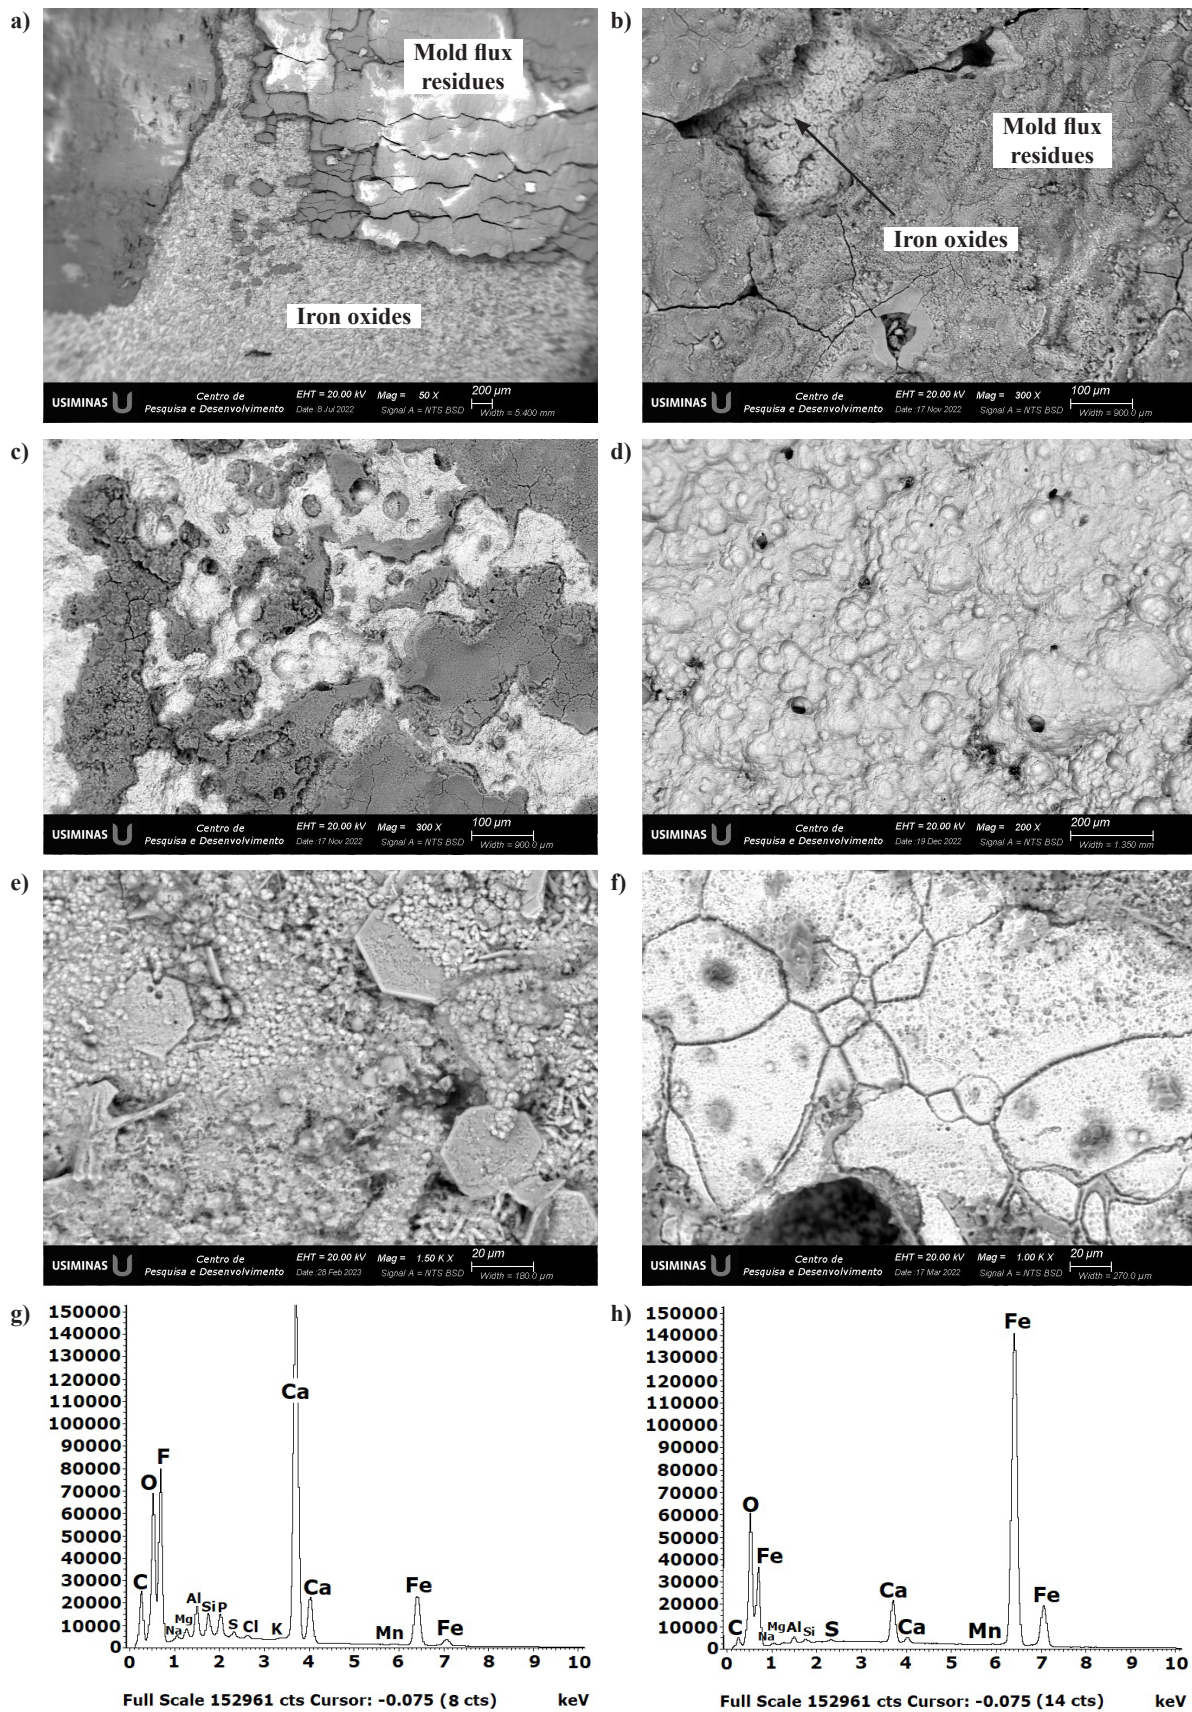
SEM/EDS analysis of the morphology and elemental chemical composition of the coupons surfaces in Figure 7. Higher intensities of counts for Ca and F predominate in the EDS spectrum of regions containing mold flux residues (Figure 7g). Iron oxides with different morphologies (Figure 7e), characterized by the highest intensities of O and Fe counts (Figure 7h), can be observed below the mold flux residue layer. Elements detected in residual in the EDS spectra, such as Al, Mg, Na, Si, S, P and K, are also related to the mold flux components.

Independently of the CCM segment where the corrosion coupons were exposed, the predominant form of attack by fluoride ions on the metal surface is the alveolar type.

It is typically caused by halogen ions and is associated with differential aeration. This type of corrosion is characterized by a rounded appearance (alveoli, craters or pit) with a depth lower than its diameter according to Frazão et al. [12], as shown in Figures 8c and 8d. As the corrosion process proceeds, these alveoli grow and/or coalesce, generating the appearance of cavities, which can perforate the metallic material. As shown in Figure 7f, fluoride ions can also promote intergranular corrosion. In Shokri's paper [13], this evidence was associated with fluoride ions adsorption in grain boundaries.

Figure 7. SEM/EDS analysis of corrosion coupon surfaces after exposure to CCM. a) Flux mold residues and iron oxides; b) Flux mold residues and iron oxides; c) Alveolar corrosion and flux mold residues; d) Alveolar corrosion - surface after pickled; e) Iron oxides with different morphologies; f) Intergranular corrosion; g) Typical EDS spectrum of flux mold sediments; h) Typical EDS spectrum of iron oxides.

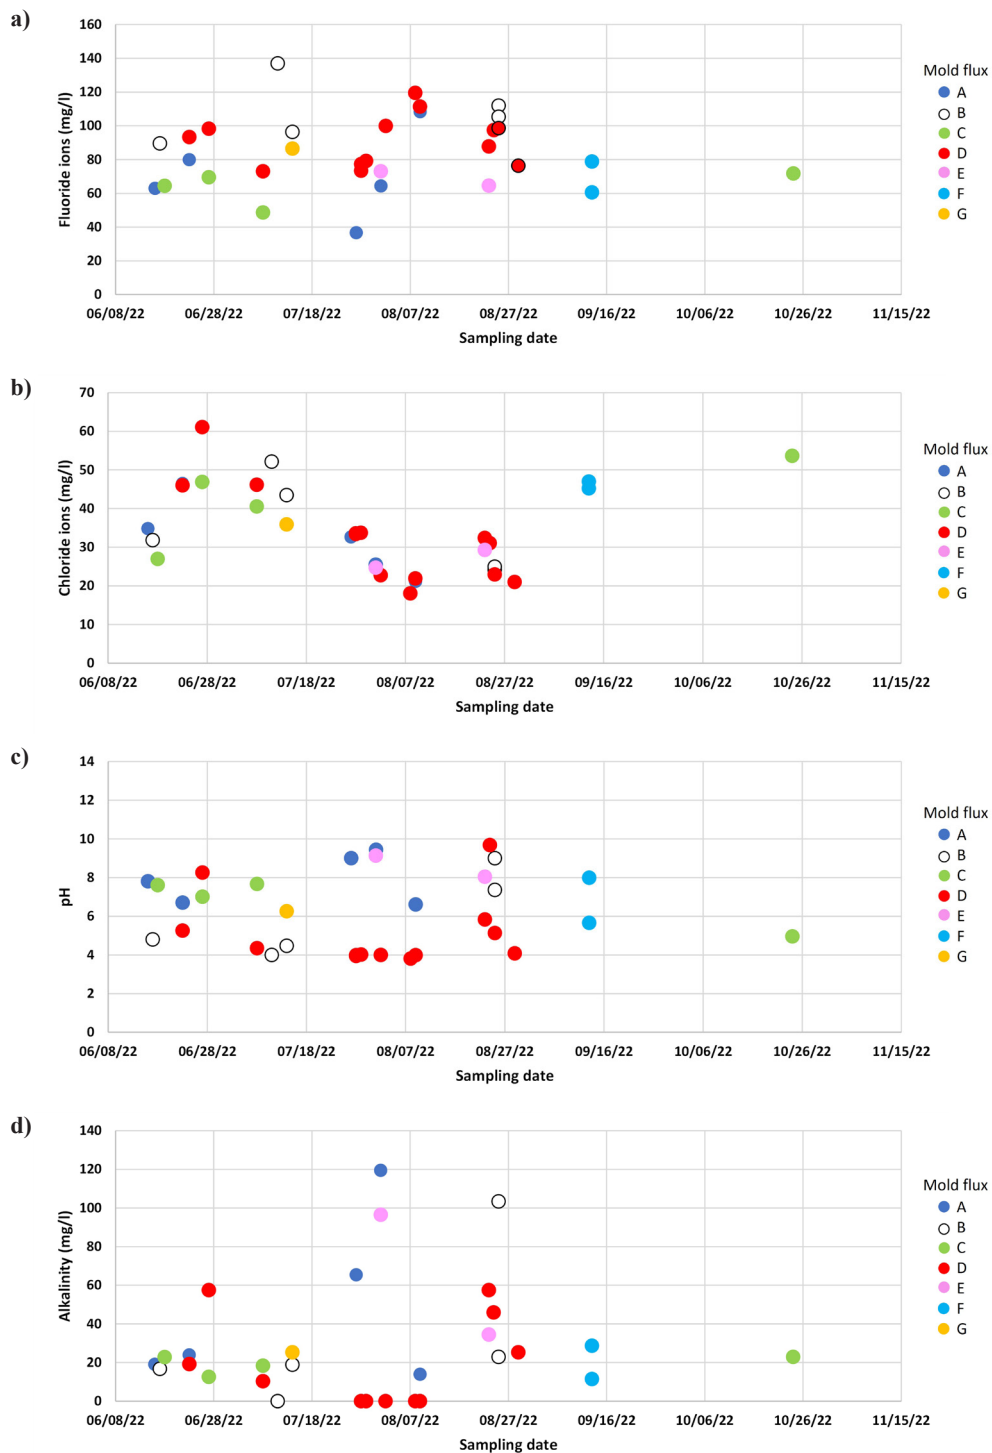
The analysis of water samples collected inside CCM#1 and #4 are shown in Figure 8. Parameters like pH, alkalinity and concentration of fluoride and chloride ions are specified in this figure by type of mold flux used in steel production. From these results, it appears that the type of mold flux has an effect mainly on pH values, alkalinity and concentration of fluoride ions. For example, mold flux B and D resulted in water samples with fluoride ions concentration above 90 mg/l; low pH, between 5.8 and 3.8, and they were the only ones with zero alkalinity, as can be seen in Figures 8a, 8c and 8d. These results can be justified by the lower volume of water used in continuous casting when mold fluxes B and D are used. The highest concentrations of chloride ions, Figure 8b, were also obtained for the aforementioned mold fluxes, including mold flux C.

Figure 8. Secondary cooling water samples analysis specified by mold flux type. a) Fluoride ions concentration; b) Chloride ions concentration; c) pH; d) Alkalinity.
