Failure analysis of hot stamping die

Abstract

It is clear, therefore, the importance of studying the wear mechanisms to which hot stamping dies are subjected. In this way, the present work proposes the initial analysis of the predominant mechanisms of failure in an end-of-life die for hot stamping.

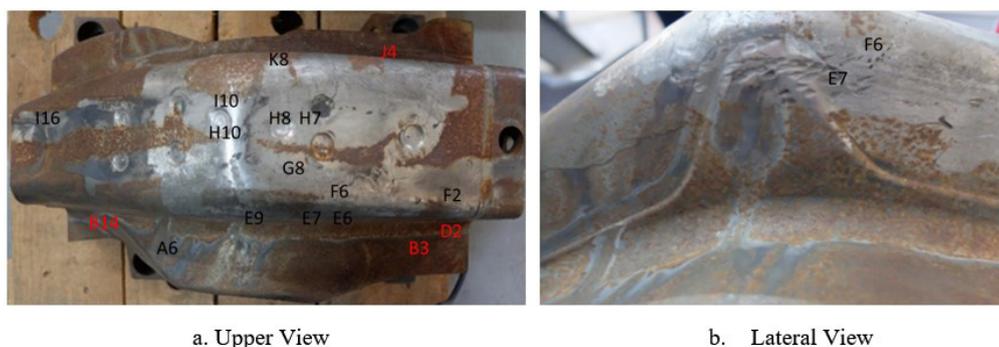
Figure 2. Photographic record of the naked eye analysis of the hot stamping die at the end-of-life.

Visual analysis of the end-of-life die showed that in the top view, Figure 2a, there are regions on the surface with rounded marks in lower cavity (H10). Such regions correspond to the places where there is spot welding on the tailored blank, used for fixing the patch. It is also possible to observe the presence of three shades of gray in the die. A metallic gray (H10, H8), a darker one (close to H7) and a lighter one (I16). The lighter gray (I16) is attributed to welding regions, resulting from die maintenance. Oxidation, visibly observable, was not considered as a failure mechanism, being attributed to the storage mode of the die. Figure 2b shows apparently crushed regions (E7) and regions with material removal (F6).

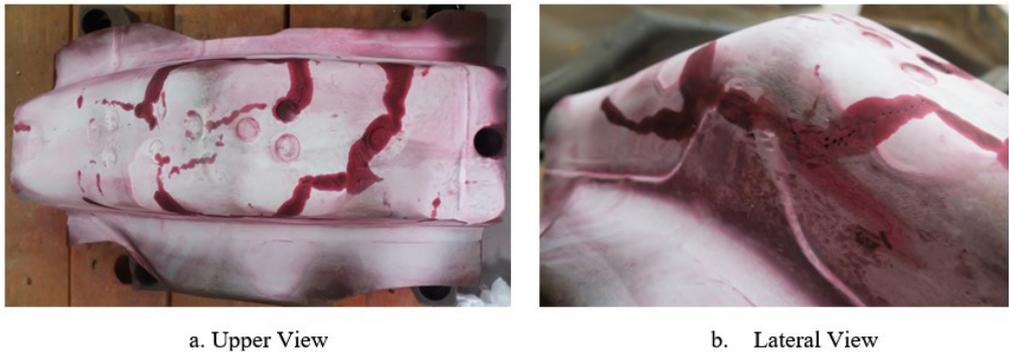
Figure 3. Photographic record of the liquid penetrant analysis of the hot stamping die at the end-of-life.

With the liquid penetrant test, it was possible to observe the regions of the die with superficial cracks, Figure 3. It is possible to verify that the cracks are found, mainly, in the regions with greater mechanical stress and that cracks propagate over long distances. In addition, there is a tendency for the cracks to be close to the points of contact with the “spot weld” (of the blank), which leads to the hypothesis that these are crack initiation regions.

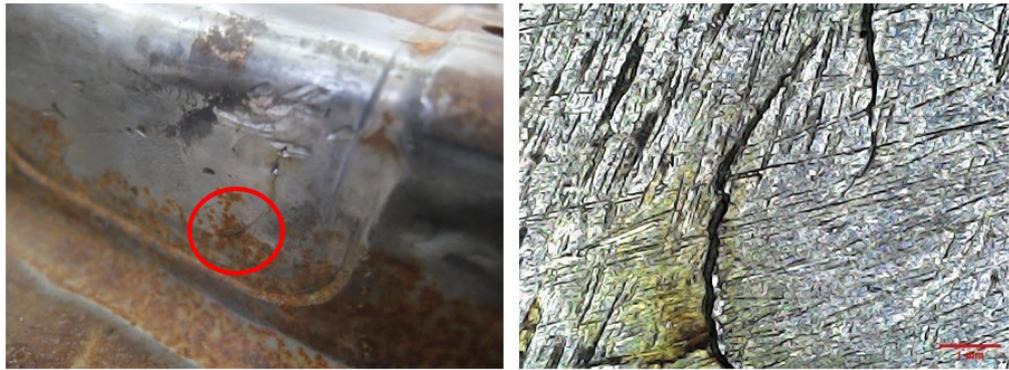
Figures 4 to 11 show representative photographs (left) and photomicrographs (right) of the wear regions. In position D2, Figure 4, grooves are observed, due to the contact of the blank material with the die, and cracks with a superficial appearance.

Figure 4. Photograph (left) and photomicrograph (right) of the end-of-life die at position D2. Cracks can be clearly observed.

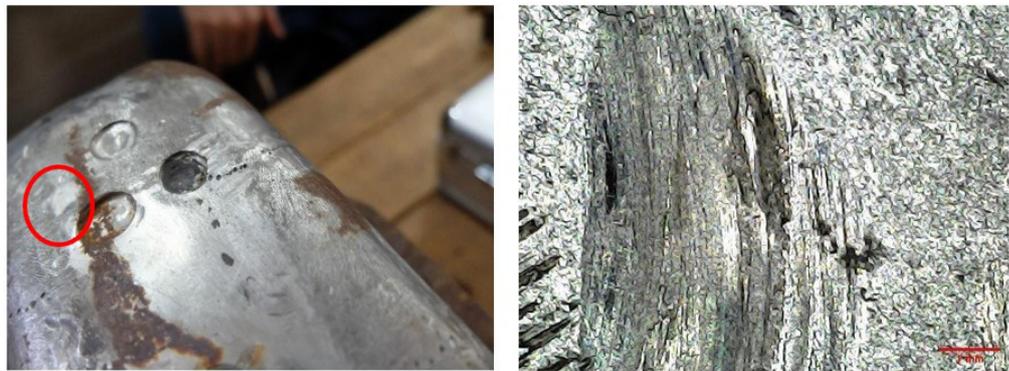
In position G8, Figure 5, unidirectional grooves can be observed, also resulting from the contact of the blank with the die.

Figure 5. Photograph (left) and photomicrograph (right) of the end-of-life die at G8 position. Grooves in the material flow direction can be seen.

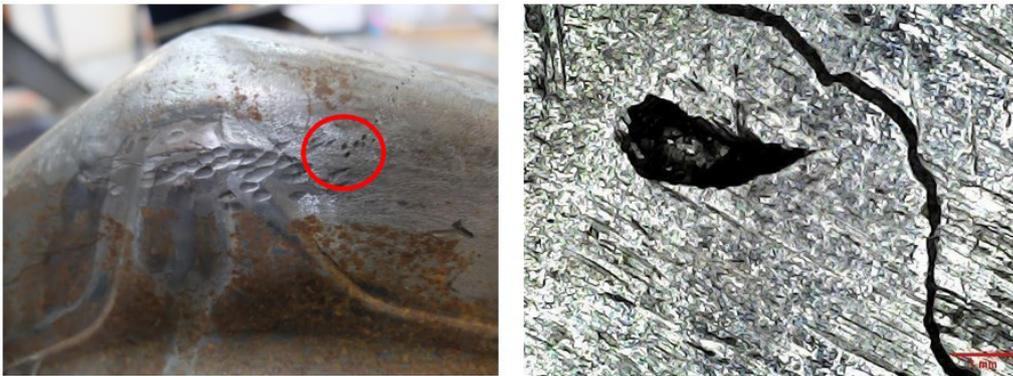
In position F6, Figure 6, there is a crack, which appears to be very deep, in addition to a deep pullout.

Figure 6. Photograph (left) and photomicrograph (right) of the end-of-life die at position F6. Material pulled out, and cracks.

Adhesive wear (sometimes used to address sliding wear) has been observed. The galling mechanism can be seen in Figure 7, due to the repeated flow of material (sliding) in that region. In Figure 6, the material pulling out is observed, attributed to die/blank adhesion.

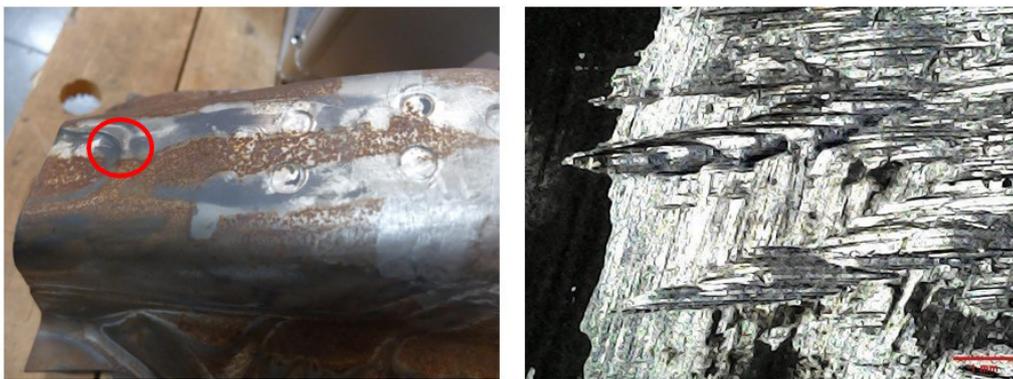
At position I16, Figure 7, grooves are observed, which seem to have a preferential direction, in addition to a material with a darker color.

Figure 7. Photograph (left) and photomicrograph (right) of the end-of-life die at position I16. Grooves.

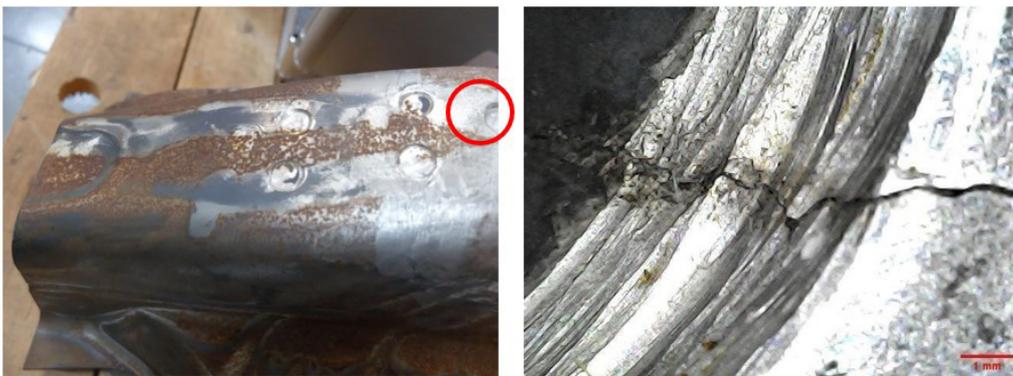
At position I10, Figure 8, one can see the wear resulting from the spot weld, which has distinct layers, indicating an uneven and progressive deformation, in addition to a crack with a thin appearance.

Figure 8. Photograph (left) and photomicrograph (right) of the end-of-life die at position I10, cracks.

Sliding wear occurred due to the flow of blank material into the die, leaving deformation marks, Figure 8, in the form of macro grooves (wear tracks). Sliding wear

has delamination as one of the micro mechanisms, which may have been the origin of cracks and material tearing.

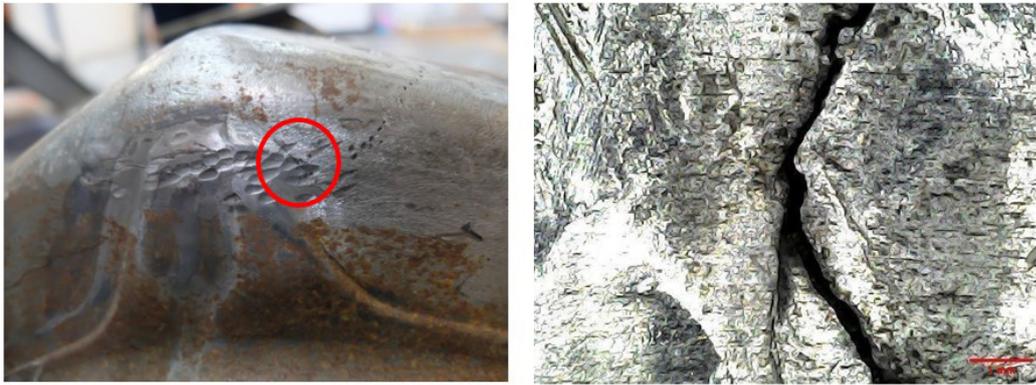
In the case of position E7, Figure 9, again, there are pullouts and cracks, but these pullouts are less profound and

occur more frequently and closer to each other. Moreover, in this case, the crack is quite deep and is in the middle of a pullout. An important observation here is the impact wear observed, evidenced by kneading.

Figure 9. Photograph (left) and photomicrograph (right) of the end-of-life die at position E7. Kneading, evidence of impact wear, and cracks.

Most of the observed wear mechanisms, if analyzed separately, may suggest abrasive wear. Additionally, the type of wear observed in Figure 9 was attributed to impact wear. In this region there is contact of the patch, which is in high salience, with the die. It can also be seen that this mechanism seems to have a preferential direction. Thus, with time, the repeated contact between the patch and the die can cause the dents and cracks observed in the region.

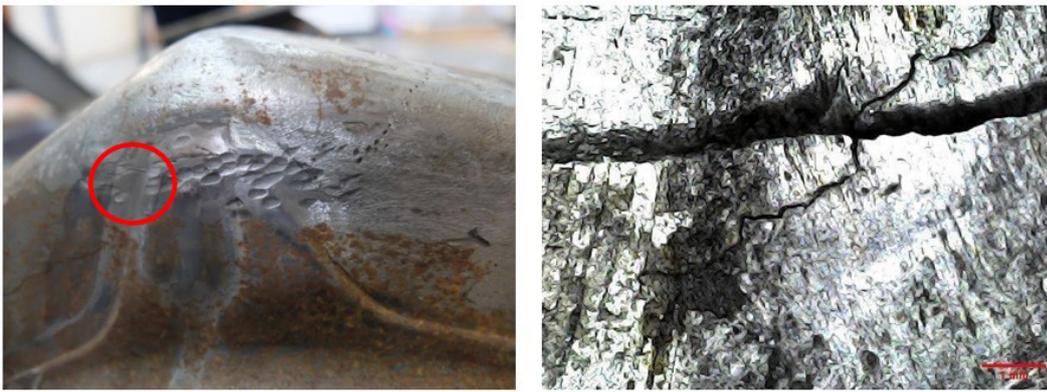
At position E9, Figure 10, cracks with different propagation directions and different depths can be noticed.

Figure 10. Photograph (left) and photomicrograph (right) of the end-of-life die at position E9, cracks.

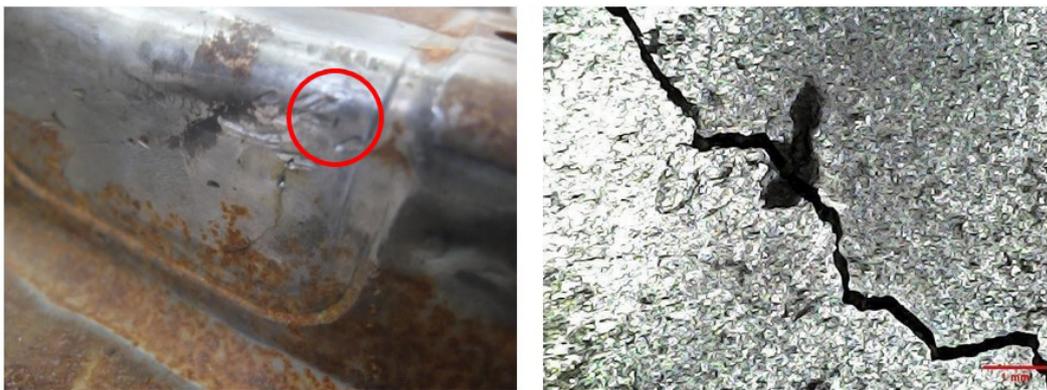
Finally, in position F2, cracks and pullouts are observed again; however, in this case the pullout is in the middle of the crack.

Figure 11. Photograph (left) and photomicrograph (right) of the end-of-life die position F2, pulling out, cracks.

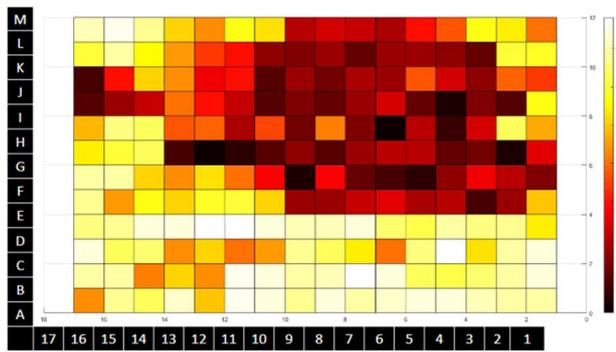
Figure 12. End-of-life hot stamping die HRC hardness map, the brighter the higher the hardness.

The hardness map, Figure 12, shows that in the regions of greater mechanical stress on the die occurs a sharp drop in hardness values (darker regions of the map), with values reaching a minimum of 20 HRC. The regions of lower mechanical stress and, probably, with shorter contact time with the heated blank, presented higher hardness values,

reaching a maximum of 59 HRC. It was assumed that the value of 59 HRC is the initial hardness value of the new die. According to the material data sheet [14], WP7v is a secondary hardenable steel that reaches 59 HRC (its hardness peak) if austenitized at 1070 °C, oil quenched, and tempered between 400 and 500 °C.

It was observed that in regions with greater wear and greater stress in the die, the measured hardness values were lower. Thus, it can be induced that the regions of greatest wear are regions in which the material overtempers due to high holding time at high temperatures (up to 190 °C [8,9,13]) and this leads to lower hardness. Modifications in the martensitic matrix during hot work were observed by Barrau et al. [12]. It is known that higher hardness values are related to greater wear resistance [6], therefore, regions with a drop in hardness during the process will be more prone to wear.

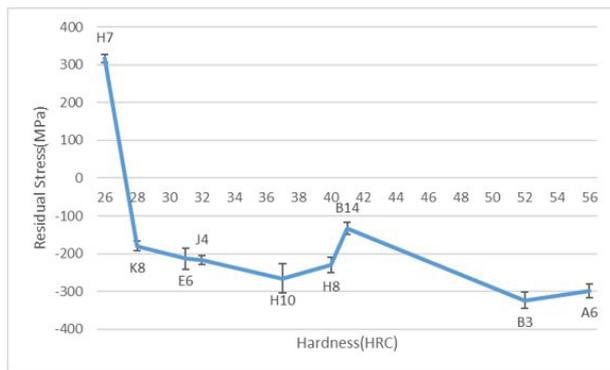
Figure 13. Graph of residual stress (MPa) X hardness (HRC).

Residual stress correlated well with hardness, Figure 13. The higher the hardness, the more compressive is the residual stress. For very low hardness values (26 HRC), the residual stress is tensile. It was assumed that the die in its “new” condition presents compressive residual stresses on its surface.

This tendency is reinforced by the results obtained in the residual stress. Among the 9 points measured, the only one with tensile stress was the point corresponding to the deformation region resulting from spot welding of the 22MnB5 plate (H7). This means that, probably, this region was a crack initiation region, confirming the previous hypothesis.

Furthermore, a relationship between higher hardness values and higher compressive residual stresses can be observed. This corroborates the hypothesis of overtempering of the tool surface, meaning that due to high temperatures found in the process there may be a change in the microstructure of the material [8,9,12], leading to lower hardness values and higher values of residual stress.
