# NEW ALLOYING CONCEPT FOR FINISHING MILL ROLLS INCLUDING RESULTS IN APPLICATION AND SURFACE TESTS

## Abstract

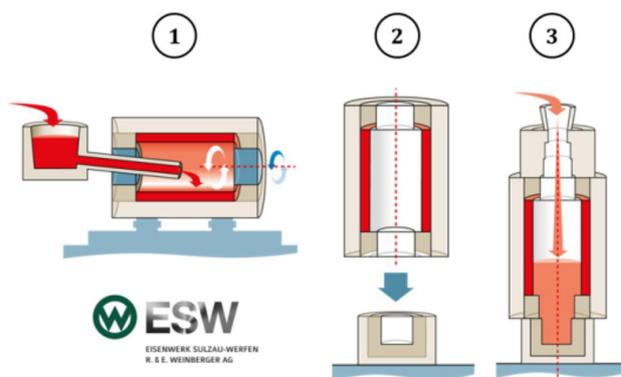
**Figure 1.** Production route of ESW's horizontal spincasting process for work rolls [11]. 1: Spincasting of the shell material, 2: Mounting of the molds, 3: Casting of the core material.

ESW rolls are produced by means of the horizontal spincasting process, see Figure 1. The first step is the spincasting itself (1) where the shell material is cast at high centrifugal forces. The solidified shell material together with the spincasting mold is transferred to the bottom mold and closed by the top neck parts (2). The final step is the core filling (usually nodular cast iron) ensuring good bonding zone between shell and core (3).

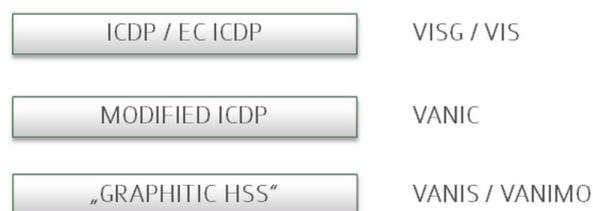
**Figure 2.** ESW's product portfolio for the last finishing stands of hot rolling mills.

ESW's product portfolio reaches from standard grade (VISG) to Carbide-Enhanced ICDP (VIS) over a modified ICDP grade (VANIC) to graphitic HSS (VANIS and VANIMO), see Figure 2.

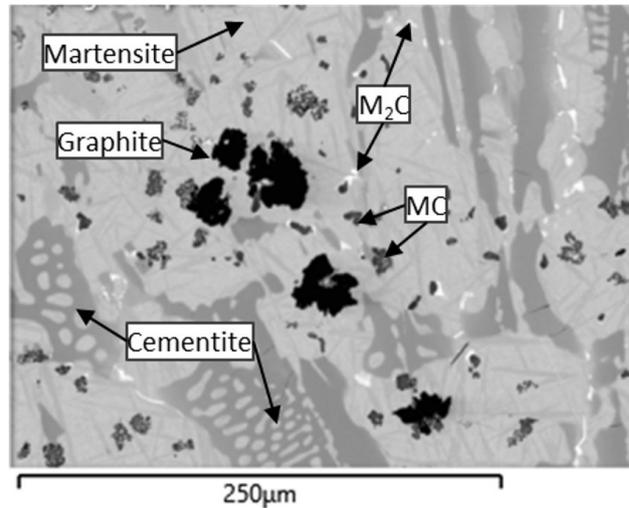
Figure 3. Microstructure of VANIMO with MC,  $M_2C$  and  $M_3C$  carbides as well as graphite embedded in tempered martensite.

The graphitic HSS roll grade has a basis microstructure, like in case of ICDP roll grades, of cementite and graphite embedded in tempered martensite. In between very hard carbides such as MC and  $M_2C/M_6C$  types are present in the microstructure. An example of VANIMO microstructure is shown in Figure 3.

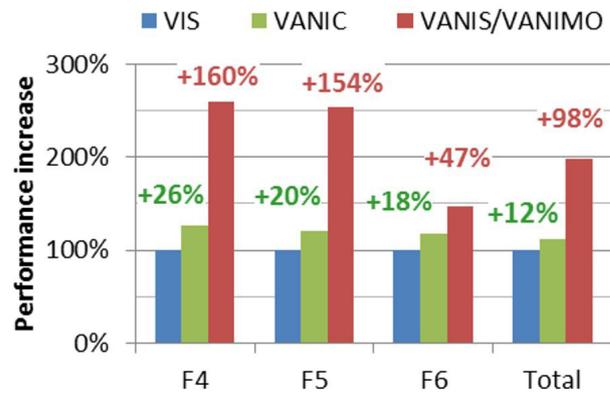
Figure 4: Wear performance of VIS, VANIC and graphitic HSS (VANIS/VANIMO) in the last 3 stands of a 7 stand mill are in comparison. In this case, the pure wear on the work roll is displayed (not the stock removal). Stand by stand the performance of the roll grades is displayed.

Figure 4. Wear performance of VIS, VANIC and graphitic HSS (VANIS/VANIMO) in the last 3 stands of a 7 stand mill.

The largest benefits were achieved in stand F4, where the performance of VANIC was +26% in comparison to VIS. The graphitic HSS grades reached an increase of +160%. This trend is also visible for VANIC and VANIMO in stand F5 (VANIC +20%, VANIMO +154%), followed by stand F6 (VANIC +18%, VANIMO +47%).

In summary, VANIC reaches +12% in comparison to VIS while the graphitic HSS grades achieve +98% in pure wear. The wear performance of the work roll is not only influenced by the work roll grade but also by the rolling conditions in the mill, obviously shown by the values.

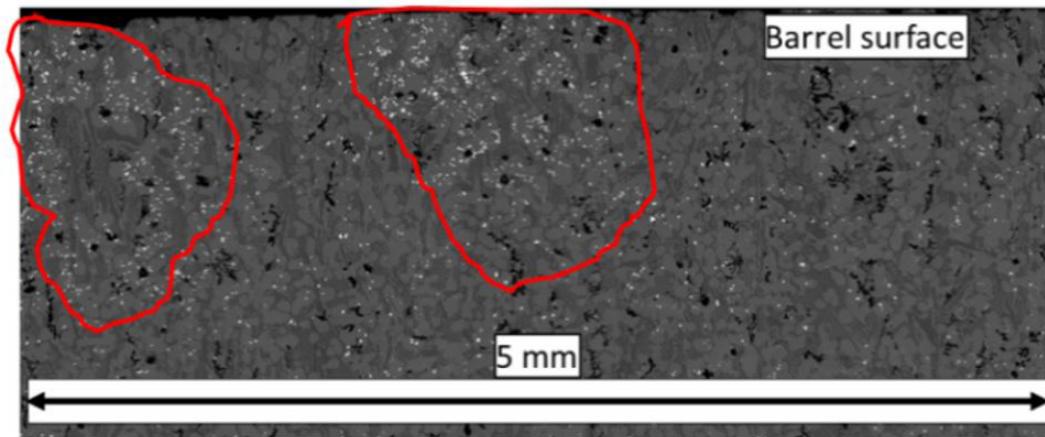
Figure 6. SEM-BSE investigations of segregated carbides in a graphitic work roll grade.

The surface shown in Figure 6 investigation clearly shows agglomerations of small MC carbides, shown in

white. MC carbides are the hardest carbide types [14,15] and therefore are highly wear resistant. The distribution of this carbide type is most important and has to be very homogenous, otherwise the wear on the barrel surface develops irregularly

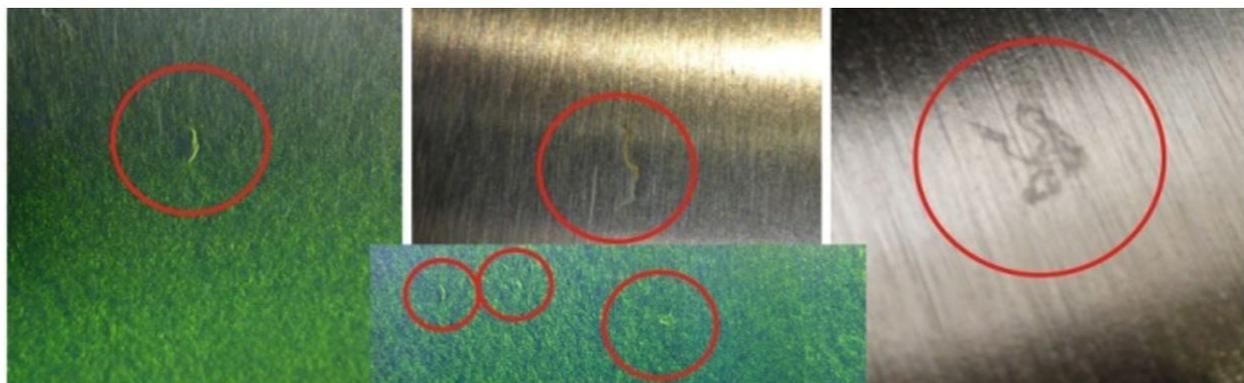
Figure 7. Typical appearance of insufficiently dissolved ferroalloys.

A full dissolution and homogeneous distribution of the ferroalloys in the melt is essential. Figure 7 shows an insufficiently dissolved ferroalloy in barrel surface with particles which lead to imprints in the rolled material. these defects may be found during roll testing, by Eddy Current (EC) or UT surface wave testing. Also liquid penetration testing (PT) or magnetic particle testing (MT) clearly reveal such defects. They appear as small cracks or porosities when they reach the barrel surface.

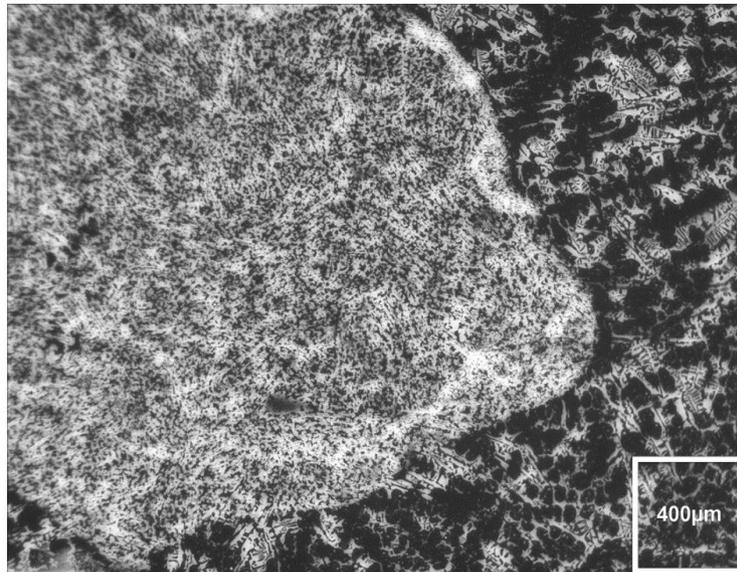
**Figure 8.** Light-optical image of an insufficiently dissolved ferroalloy.

A metallographic sample taken from including such a defect and etched with 5-% Nital, the microstructure looks as shown in Figure 8. Carbides appear white and the matrix as well as the graphite particles are black. The normal microstructure shows typical ledeburitic carbides with an area fraction of about 35%. The insufficiently dissolved ferroalloy has a much higher carbide fraction and much finer structure.

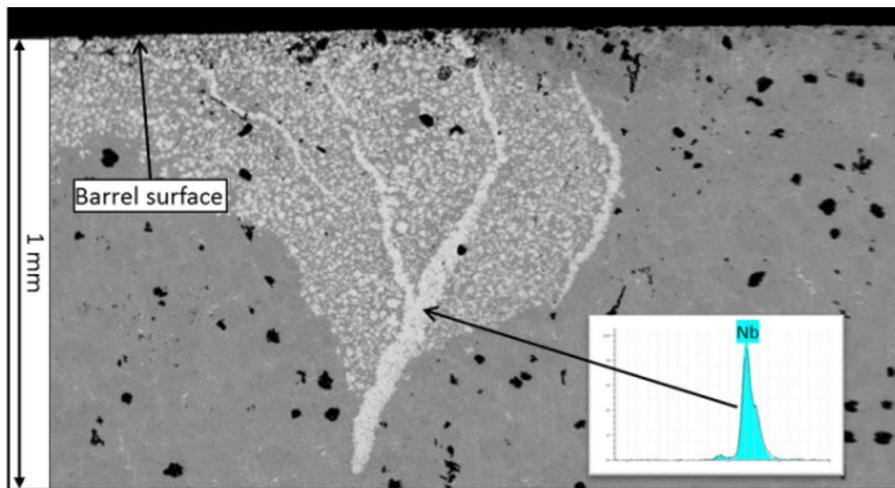
**Figure 9.** SEM-BSE image of the depth profile of insufficiently dissolved FeNb.

Figure 9 shows the depth profile of such defect. The round graphite particles are shown in black, the matrix and cementite in grey. The white structure is showing the insufficiently dissolved ferroalloy in a leaf like structure. The particle depth is approximately 1 mm from the barrel surface. The dissolving

process was just in progress when the metal solidified. The EDX scan confirmed the particle contains high fraction of Nb which means that the dissolving process of FeNb was insufficient.

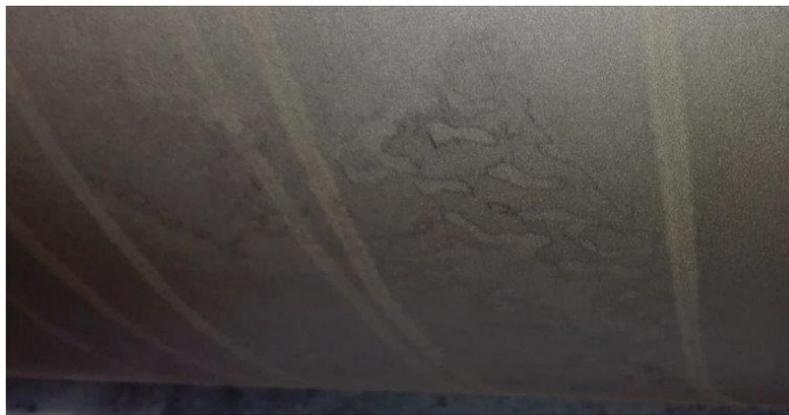
**Figure 10.** Possible appearance of “degenerated” carbides on the barrel surface.

For high-performance work roll grades such as VANIMO, not only the morphology of carbides but also the correct amount and type is essential. Figure 10 shows an example, where “degenerated” carbides are present. This means

carbides with unusual morphology – lead to some surface pattern on the work roll. The pattern in Figure 10 somehow look like water spots but with metallurgical background.

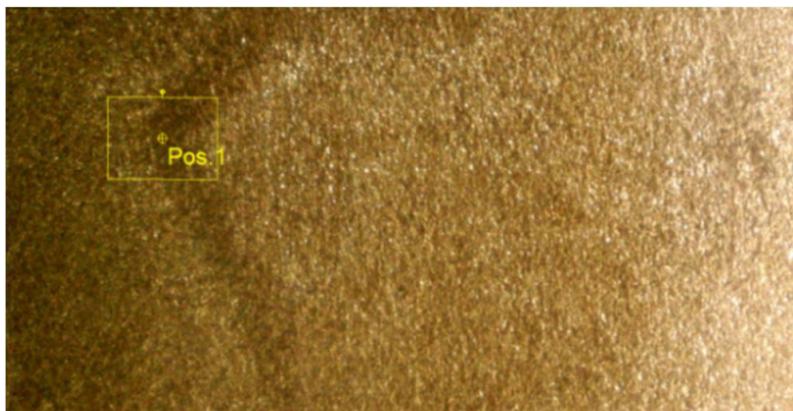
**Figure 11.** Detail of degenerated carbides.

Figure 11 gives a detailed view on such “water spot line”. It reveals its macroscopically clear line appearance. Performing a large area EDX mapping shown in Figure 12 tells that the amount of V is not homogeneously distributed. V is agglomerated in one line which is the same as the macroscopically visible one.

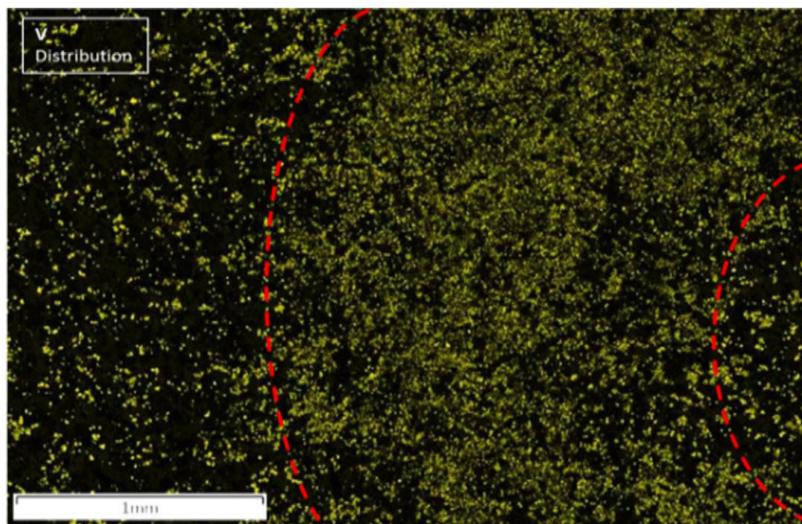
**Figure 12.** SEM large area mapping of V distribution.

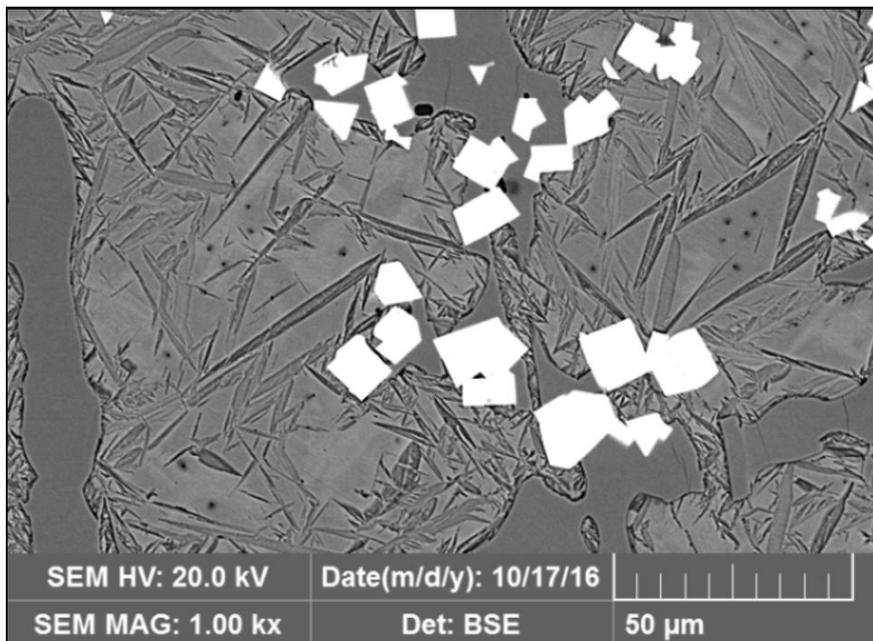
Figure 13. Cubic morphology of MC carbides (white) in a graphitic work roll grade.

Looking at the morphology of the MC carbides clear deviations between two MC carbides types are detectable. The first type is shown in Figure 13, where the white MC carbides appear in a clear cubic structure.

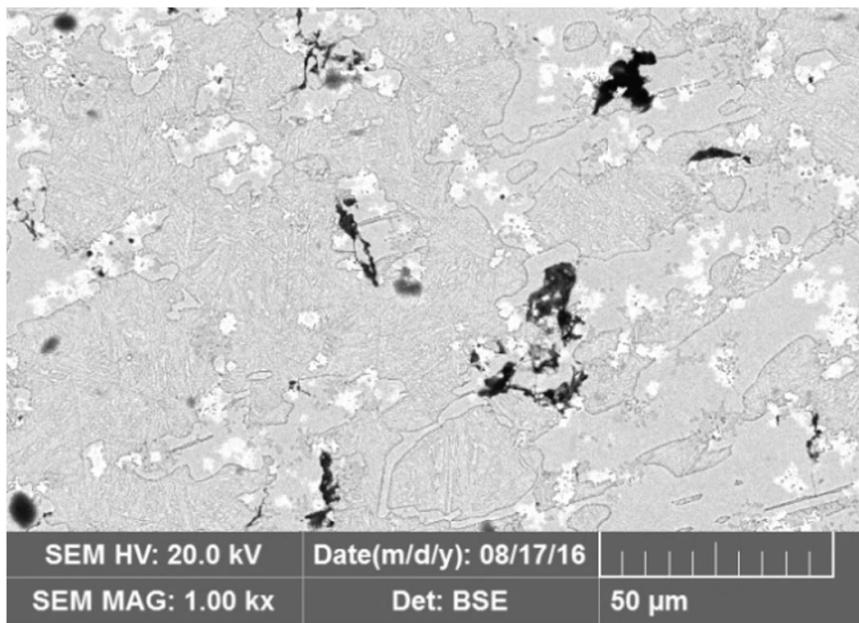
Figure 14. SEM-BSE image of degenerated MC carbides (white).

The MC carbides (white in the picture) have a more irregular shape. They are much smaller than the ones in Figure 13. In addition they tend to agglomerate and form lines which result in “water spot lines” on the barrel surface.

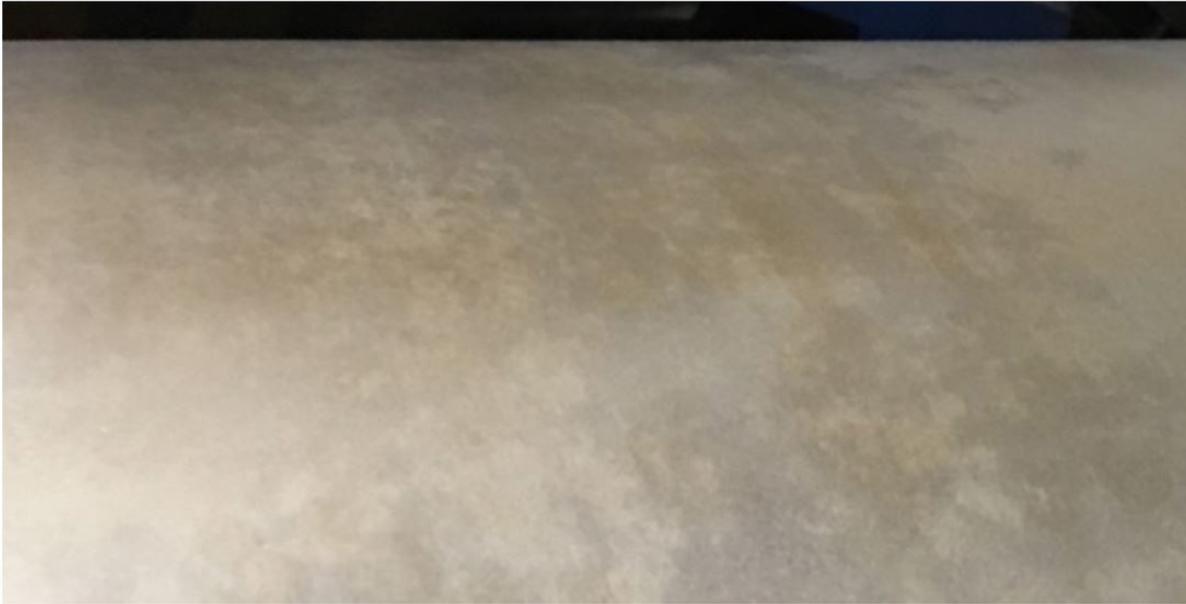
**Figure 15.** Barrel surface with “cloud-pattern”.

Up to now the defects on the barrel surface were clearly related to microstructural and therefore metallurgical aspects in roll manufacturing. A very critical phenomenon is the formation of a “cloud-pattern” on the surface of ICDP roll grades. Figure 15 shows the appearance of this defect on the barrel surface.

It can be described as very small variations in the surface of the work roll and can be very hard to identify. Anyhow in some mills and some applications the pattern

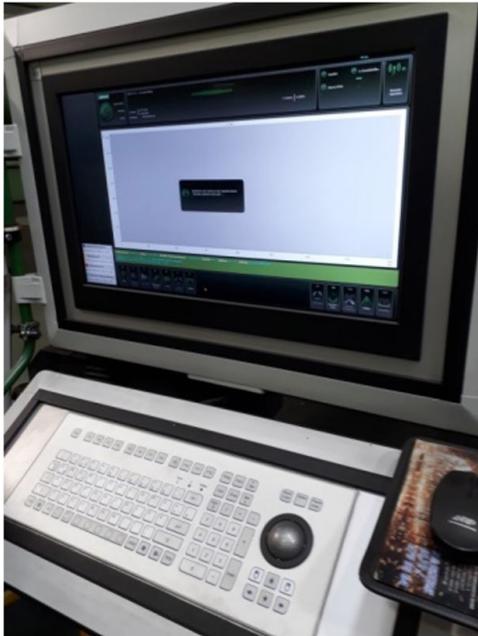
Figure 16. LRI Control Panel (Screen and PC).

The new LRI configuration is very compact. A controlpanel with screen and integrated PC as shown in Figure 16 is installed on the grinding machine. The second part is the so called iPPS (intelligent Probe Positioning System). This part controls the probehead very accurately towards the roll surface to perform the automation. See Figure 17

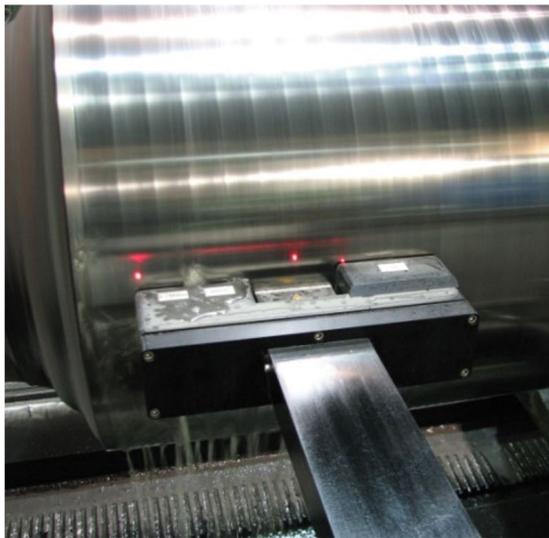
Figure 17. LRI intelligent Probe Positioning System.

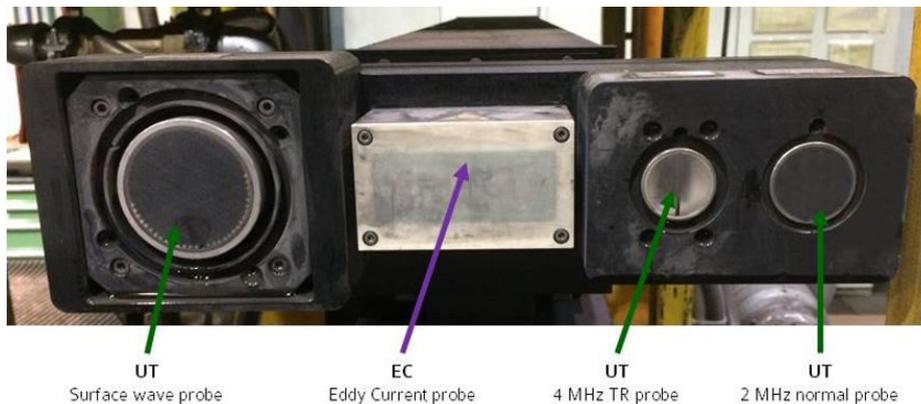
Figure 18. Probe head configuration.

Figure 18 is showing the actual probe head configuration of this ESW automatic roll inspection system. There are the 3 described UT probes, same as in the

former configuration and the new eddy current sensor in the center of the probe head.

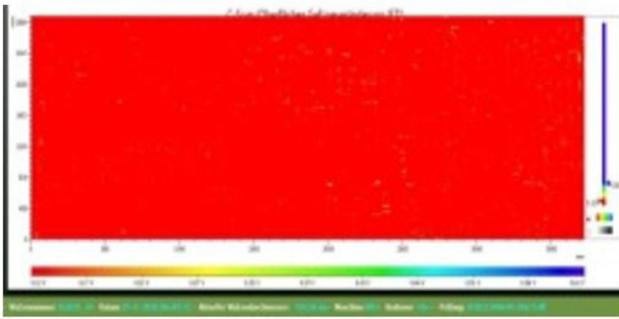
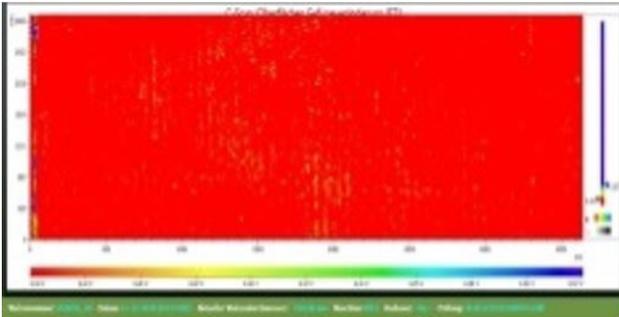
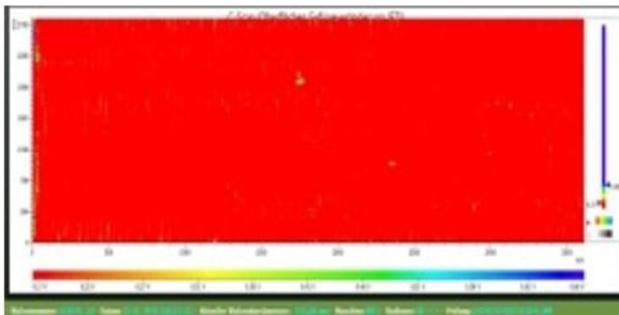
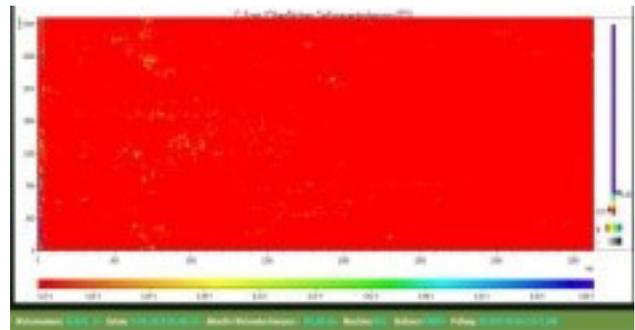
Figure 19. C-scan at Ø 935mm.

Figure 22. C-scan at Ø 905mm.

Figure 20. C-scan at Ø 925mm.

Figure 23. C-scan at Ø 895mm.

Figure 21. C-scan at Ø 915mm.

For this investigation we took a special alloy of chrome cast steel. To see if the alloy is uniform we ground the roll in 5mm steps down followed at each step by a scan on the LRI System. The following Figures 19-23 show the different stages of the ground roll.

In the different figures we can see, that some microstructural indications appear and disappear. The metallurgical background is a small variation in the carbide content of the ledeburitic network carbide.

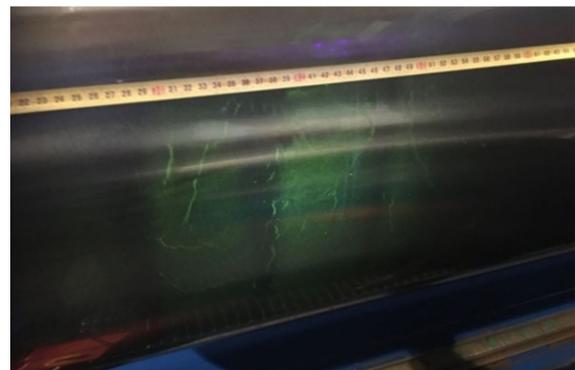
Figure 24. Fluorescent magnetic particle test under UV light.

Figure 24 shows the detection of a surface pattern during service in the rolling mill. The roll was one of the first rolls tested on the new LRI System at ESW.

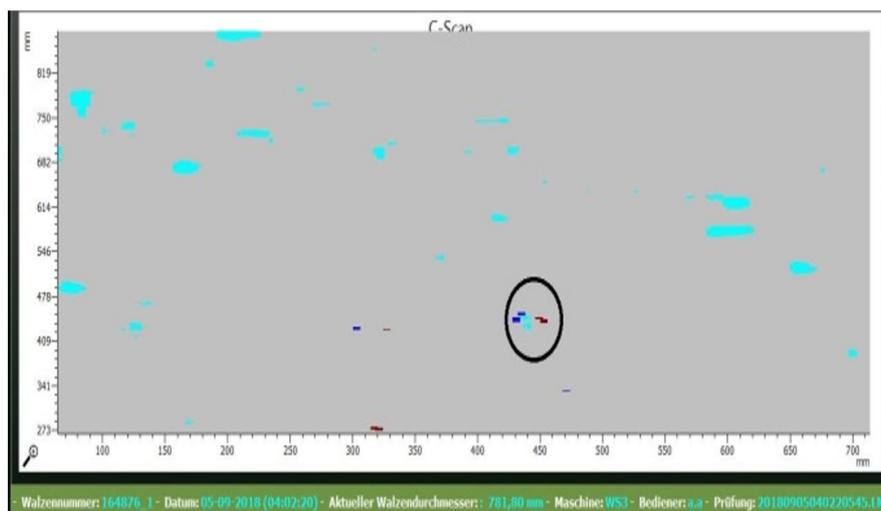
Figure 25. Indication of detected area on the roll.

Figure 25 shows the detection in the circled area containing signals from the 2 directions of the surface wave probe and the EC microstructural indication.

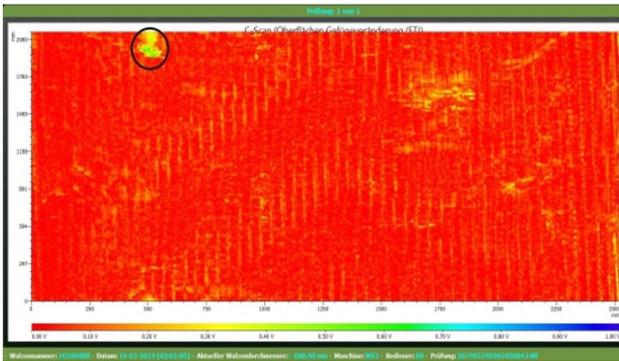
**Figure 26.** EC C-scan microstructure changes.

The EC microstructure of a HSS roll gave some indication as shown in Figure 26 and marked with the black circle.

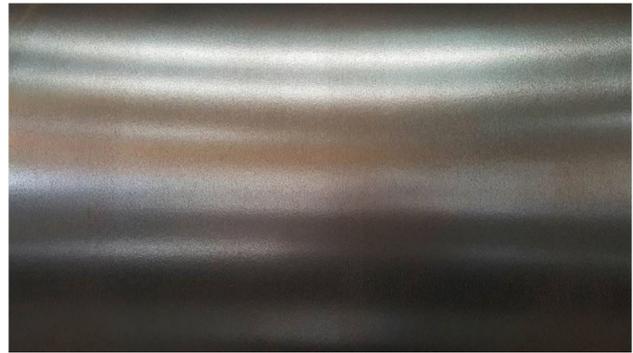
**Figure 28.** Smooth VANIMO barrel surface without irregularities after rolling a campaign with ~4700 tons.

The surface quality of ICDP as well as graphitic HSS grades is essential for a proper usability in the rolling mill. Possible surface defects were presented and the remedies were discussed. The new possibility to detect such surface discontinuities with EC test methods makes it possible to make tests inhouse and achieve results in shorter time and less workload in the mill. Together with our customers we try to achieve a smooth barrel surface as shown in Figure 28.

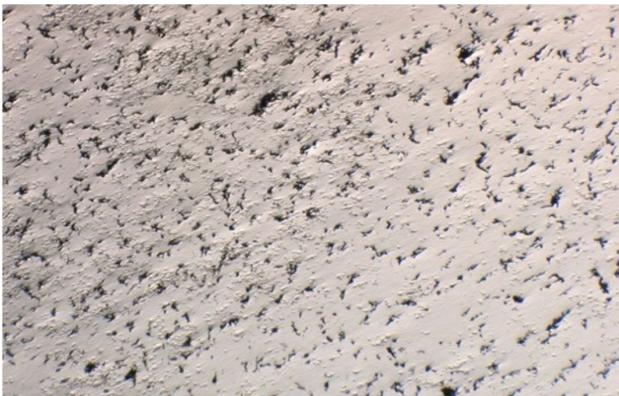
**Figure 27.** Left top, MC carbide agglomeration.

Then metallographic investigation took place. As can be seen in Figure 27, the metallographic investigation brought up the high density of MC carbides. This gives a high signal in the EC microstructure channel. In total the

MC precipitation was not uniform over the localized area in the barrel.
