# Tribological analysis of wear plates in the hopper of a car dumper

## Abstract

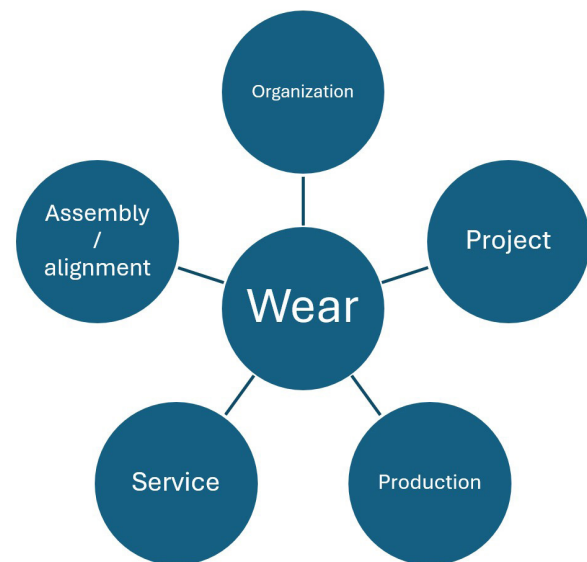
**Figure 2.** Factors influencing the wear of structures [1].

Economic losses related to wear can be reduced by optimizing the organization's plant and by proper design, production, assembly, and application. Controlling the cost of wear can begin with the correct production process for manufacturing the product, which includes the selection of equipment and installation location, standardization issues, and inventory, as shown in Figure 2.

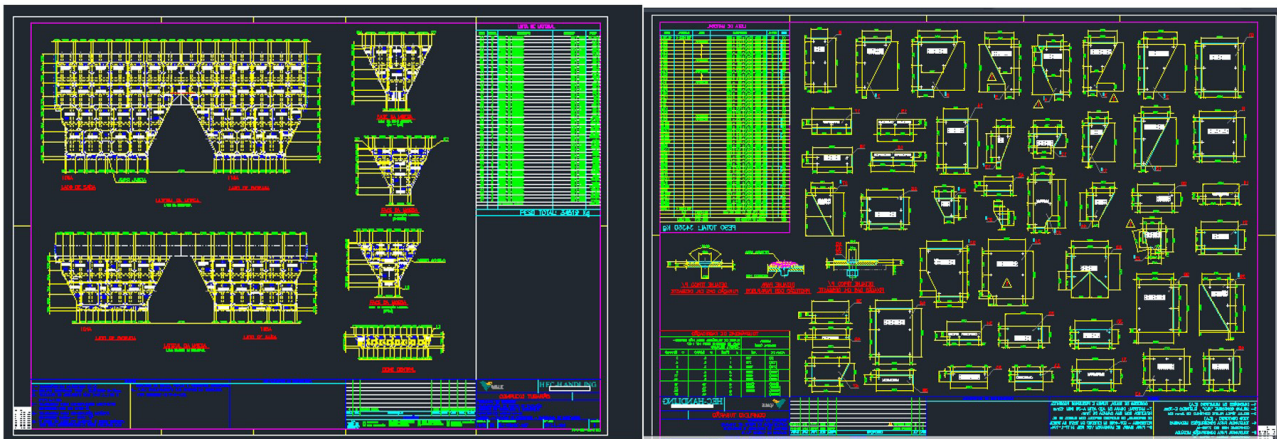
To evaluate wear mechanisms and enable comparison between different coating compositions was proposed a test applied on a hopper of a car dumper according to Figure 3.

**Figure 3.** Design of the hopper and wear plates in the car dumper.

- Maximum Number of Wagons per Train: 90 units;
- Car Dumper Load Capacity: 2 x 110 tons/cycle;
- Average Discharge Cycle: 80 seconds;
- Material Handled: Pellets, Fines and Granulated Ores;
- Feeder Capacity: 4,000 t/h;
- Useful Length of Feeder Guides: approx. 5.35 m.

This application of the plate was chosen because it is a location with severe abrasion and moderate impact. Another determining factor in this analysis was the use of a material that had a relatively short lifespan, ranging from 4 to 6 months in operation. These are bimetallic plates with a hard coating composed of chromium, niobium, and boron, with a hardness of 60 to 65 HRC at a thickness of 19mm, of which 7mm is the hard layer.

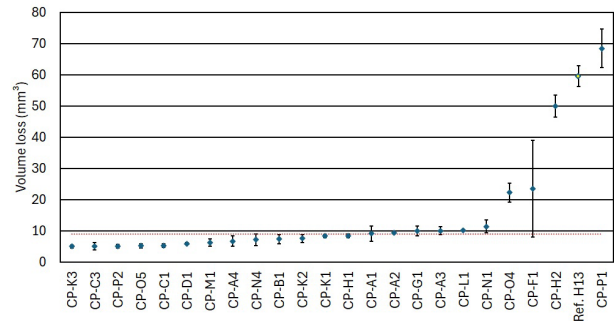
In Figure 4, the obtained values of wear resistance of the weld-coated, cast, or chocky bar plates can be seen. The test specimens CP-K3, C3, P2, O5, C1, D1, M1, A4, N4, B1, K2, K1, and H1 showed the best wear results with average volume loss values below the overall average of  $9.1\text{ mm}^3$  (red line in the figure).

Figure 4. Average volume loss per material.

requirements of the analysis in the KPIs as shown in Table 3, confirming a satisfactory result obtained in the G65 rubber wheel abrasion tester [7] in Figures 4 and 12.

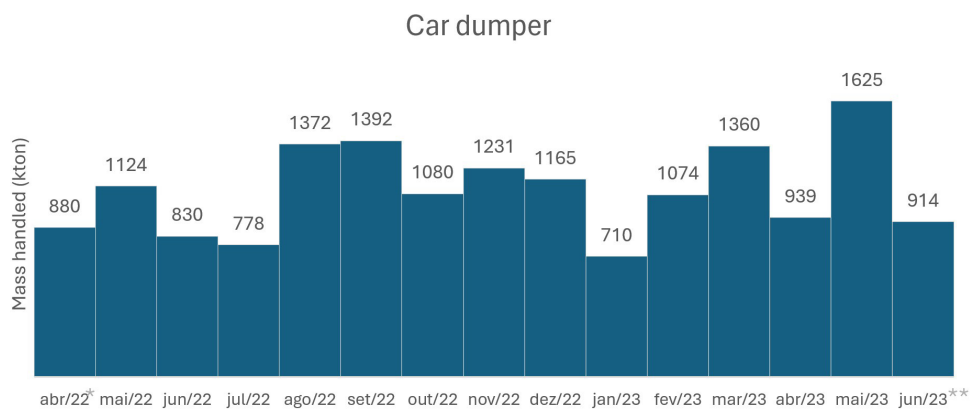
Figure 10. Mass handled in the car dumper during the tests.

The Figure 10 presents a summary of the mass handled in the car dumper during the tests realized from April 2022 to June 2023 (442 days of operation), totalizing 16.474 kton.

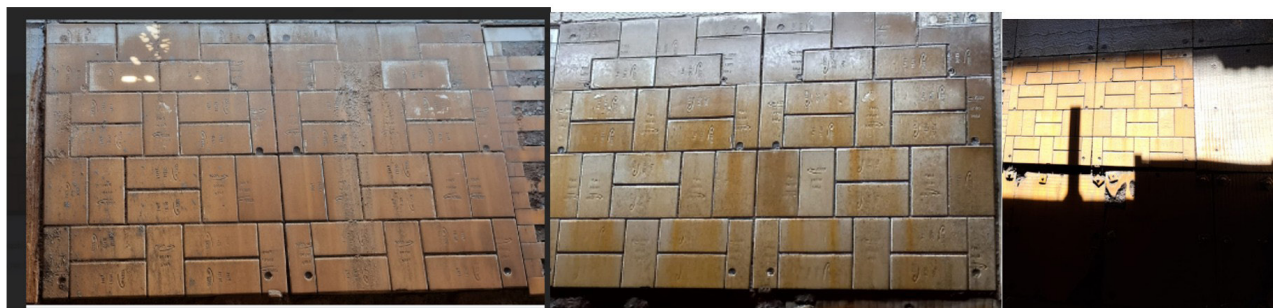
Figure 11. Status of the wear plates after a 1-year test period.

The monitoring of inspection and maintenance activities carried out during this period found that the wear plates did not experience excessive wear causing any hole and material loss in about 1 year in operation (Figure 11).

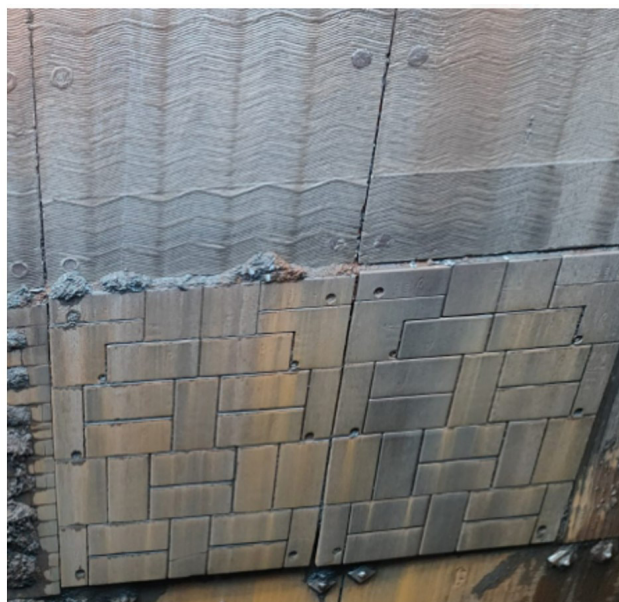
Figure 12. Status of the wear plates after a 2-year test period.

The Figure 12 shows the current condition of the tested plate, which after 2 years of installation is still performing satisfactorily.
