Corrosivity study in Usiminas continuous casting machines segments

Abstract

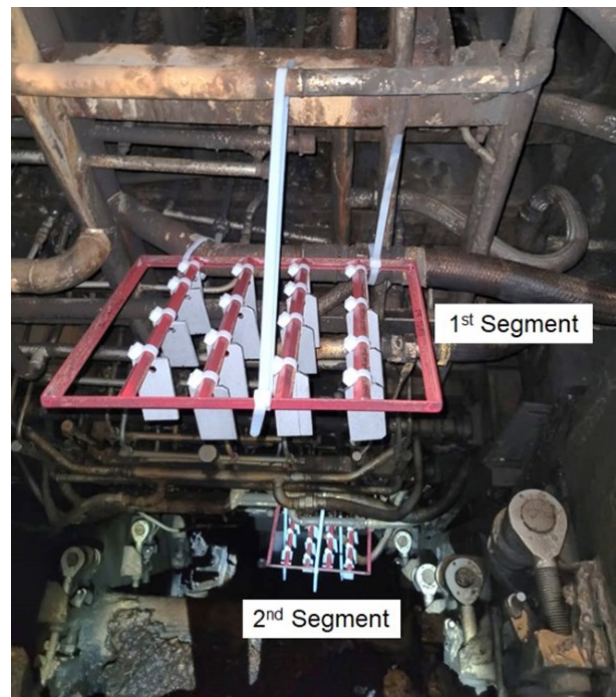
Figure 3. Arrangement of corrosion coupons inside the CCM.

Corrosion tests included the determination of the corrosivity of the environment, evaluations of corroded surfaces and characterization of corrosion products. Corrosion coupons of unalloyed carbon steel were made in 100 x 50 mm x 6 mm dimensions, pickled with HCl solution, dried and kept in a desiccator for 24 h. In sequence, the coupons were individually weighed and exposed at CCM#1 and #4 of Usiminas Ipatinga plant. As shown in Figure 3, the corrosion coupons were properly

fixed on a support, which was placed in segments 1, 2, 3 and 8 of the CCM. The first three segments are characterized by a greater corrosive attack on CCM structures, unlike segment 8, where the corrosion is not severe.

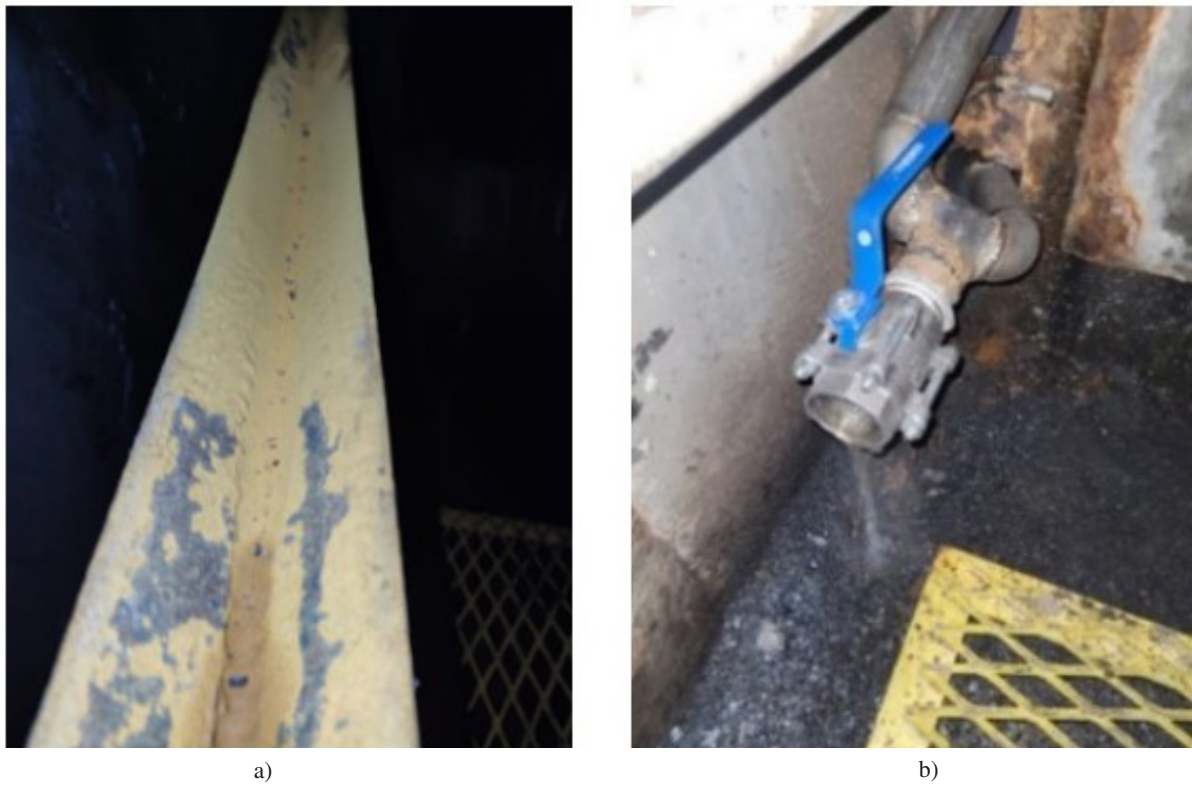
Figure 4. (a) Channel for water collection and (b) opening valve.

Water samples were collected from two different points: (i) at the CCM water recirculation center (CRALIN) and (ii) at the CCM spray system, where it was necessary to put a channel, positioned between the 2nd and 3rd segments, and an opening valve outside the machine, in order to generate a representative sample of the points most affected by corrosion, as are shown in Figure 4.
