Fragility analysis under low temperature of steel alloy used in helicopter bolt

Keywords: Bolt; Temperature; Toughness; Ductile-brittle transition.

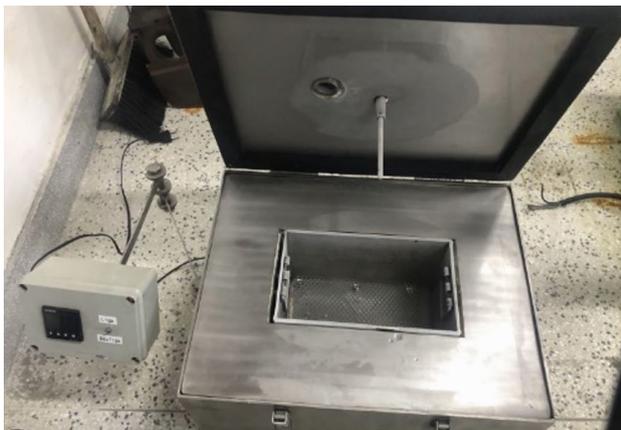
Figure 2. Sealed tank employed for Charpy samples cooling.

The preparation of the specimens for the Charpy impact test was performed using the bolt milling and finishing with grinding by ASTM E23 [15]. In total, twelve samples were tested, three samples at each temperature, under the conditions of -40 °C, -20 °C, 0 °C, and 25 °C with type C notch (Charpy-U). The samples were cooled through a sealed temperature stabilization tank (Figure 2) and temperature measurement using K thermocouple. Sub-zero temperatures were reached with the use of liquid nitrogen.

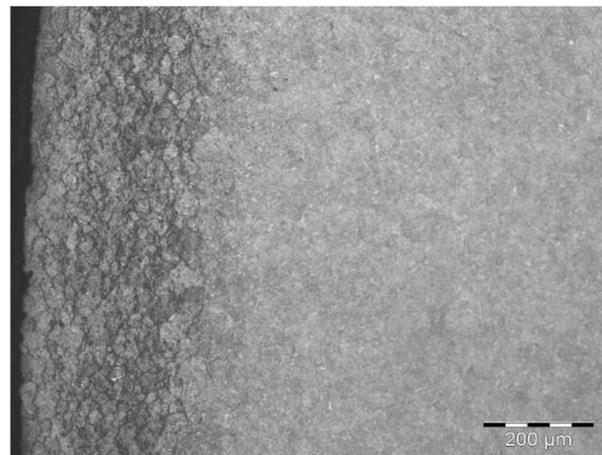
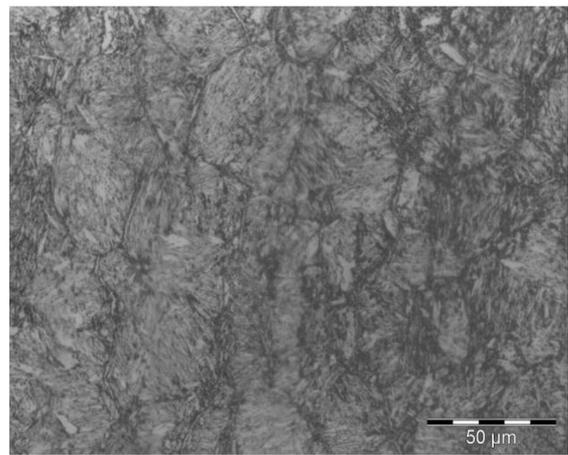
Figure 3. (a) Bolt surface evidencing the presence of superficial treatment and (b) martensitic microstructure presented in the bolt core.

The optical microscopy evidenced surface treatment due to the presence of microstructural gradient from the sample edge towards the bolt core, and using ImageJ software, a layer measurement of 0.352 mm was verified, according to Figure 3 (a). Within the core it was identified the presence of a full martensite matrix, Figure 3 (b). Similar microstructure it was founded by Krstic et al. [8] during the investigation of bolts of chromium-nickel steel applied on helicopters consisting of typical fine-grained tempered martensitic microstructure (needle-shaped).

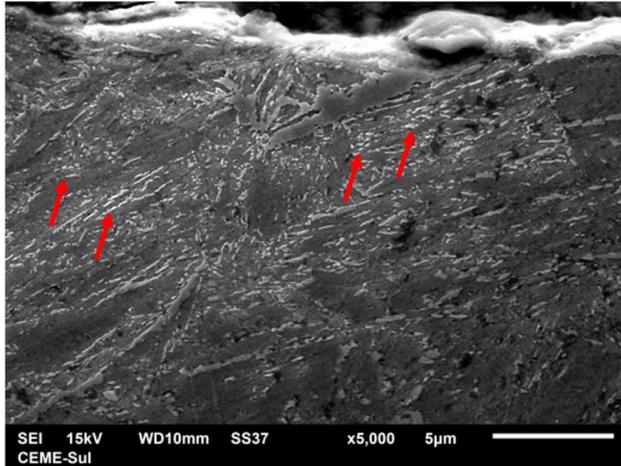
Figure 4. Bolt surface indicating presence of precipitates (indicated by arrows).

Figure 4 shows the microstructure of the bolt surface obtained by scanning electron microscopy, indicating the presence of precipitates (indicated by arrows).

Due these different features noted between the surface and the core observed on the Figure 4, dispersive energy spectroscopy (EDS) was performed by scanning electron microscopy (SEM). This EDS results demonstrated different chemical concentration between the surface and the core.

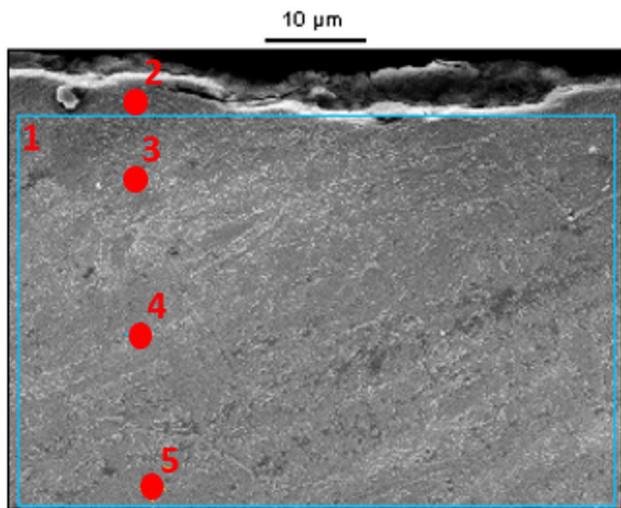
Figure 5. Measuring spots analyzed by EDS.

Table 2 shows EDS analysis results from the spots starting from the surface region towards the bolt core, these spots are indicted within the Figure 5. Even though EDS analysis is not precise for carbon, a higher amount of carbon was detected suggesting thermochemical treatment existence, moreover the presence of nitrogen at significant concentrations was identified. X-ray diffraction (XRD) analyses as well were performed, but the results were not conclusive for reliable identification of carbonitrides or other compounds. The low and undetectable amount of secondary carbides and nitrides obtained on the performed XRD analyses may be associated with an insufficient initial base material amount of Nb, V, Ti e Al on the bolt base material associated with thermochemical treatment parameters applied on the bolt manufacture process [16-18]. Krstic (8) as well detected chromium carbides precipitates on the surface of bolts made of chromium-nickel steel used on helicopters.

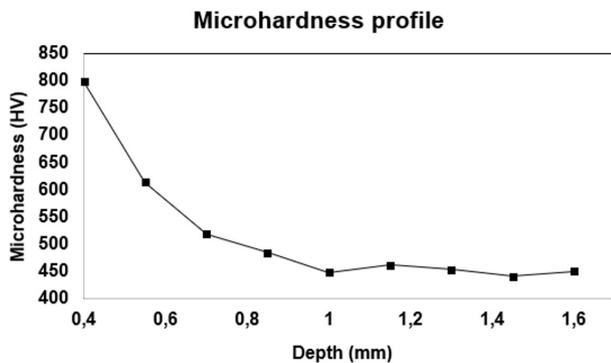
Figure 6. Bolt microhardness profile

Figure 6 shows the microhardness profile along the cross-section of the bolt. The maximum measured value was 800 HV, and the core value was 450 HV. The maximum value within the layer and thickness size observed is compatible with the carbonitriding process, according to Totten [16]. Also, the microstructure observed on the surface and the core and mainly the chemical composition values obtained corroborate and well-matched with typical carbonitriding product characteristics [19]. Carbonitriding is an efficient thermochemical heat treatment used to improve surface properties, as it increases hardness and, consequently, wear

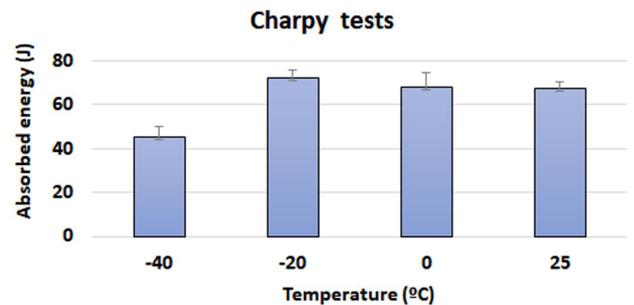
Figure 7. Absorbed energy as a function of the temperature for the Charpy tests.

The values obtained through the Charpy tests (Figure 7) were plotted in as a curve (Figure 8) to establish the ductile-brittle transition of the steel analyzed. Each temperature condition was tested using three samples in each, i.e., at temperatures of -40 °C, -20 °C, 0 °C, and 25 °C.

It was observed that the mean values obtained at -20, 0, and 25 °C showed small differences reaching a plateau of absorbed energy, nonetheless the standard deviation for 0 °C was more significant. However, in the test condition at -40 °C of temperature, a considerable decrease in absorbed energy was observed. The toughness decrease with temperature decrease is already expected because it is a characteristic of materials with a crystalline structure of body-centered cubic

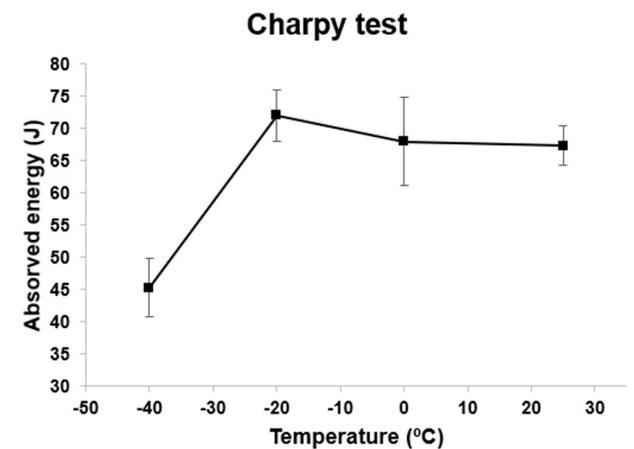
Figure 8. The ductile-brittle transition curve obtained by the Charpy tests.

(BCC), presenting this decrease in toughness with the drop of the temperature. However, the presence of precipitates in the material matrix plays an essential role in the initiation of cleavage fracture [21], which may thus have contributed to the significant decrease in energy absorbed at - 40 °C tested temperature. An effective approach to increase the toughness of steels is to increase the alloy's cleanliness, especially in the decrease of sulfur and phosphorus contents [2].
